CLOCK SPRING®

The Fast, Economical Solution for Low Pressure Pipeline Repair

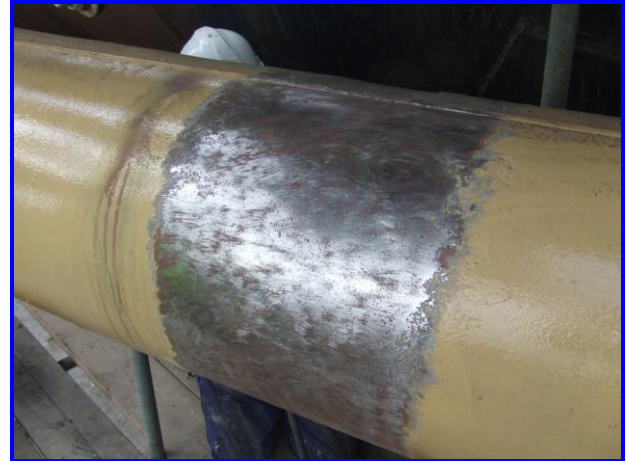
Up to 50% internal wall loss in 2 patches with a maximum axial length of 200 mm.

Defect and surrounding pipe cleaned to S.T. 3

The existing epoxy coating was removed using sanding disks and the bare pipe metal was exposed, grit blasting was not suitable at this location.

High compressive strength filler was placed in the defect area, to pass the loading from the defect to the Clock Spring.

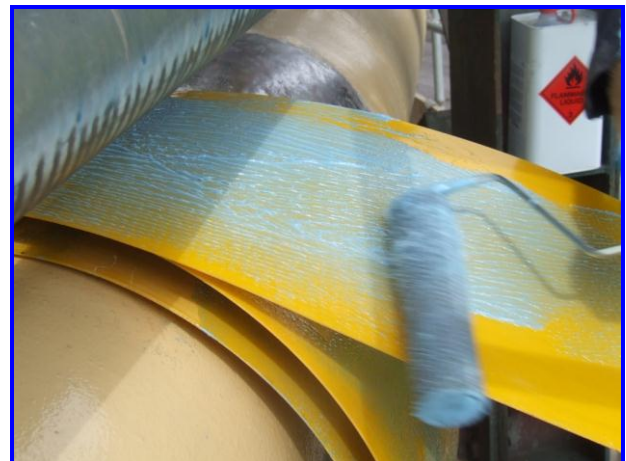
Repair installed using the "hand spool" method

A 20" Clock Spring was installed under the supervision of a Clock Spring technician using the "hand spool" method which is used in areas with tight access.

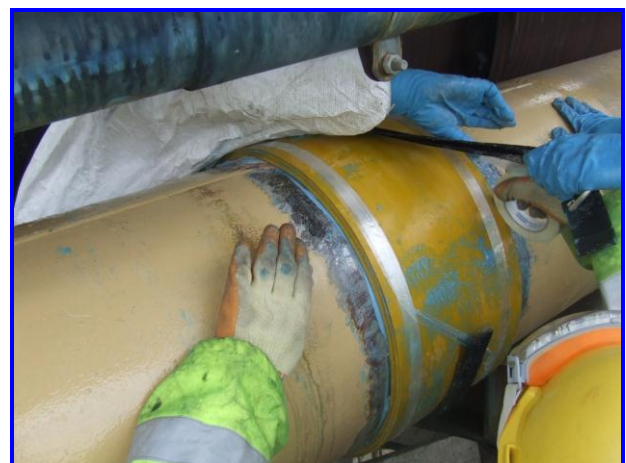
Repair tightened and taped while it cures

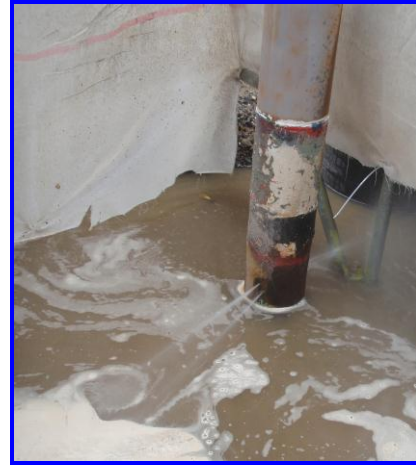
Wall thinning in the air to ground interface zone with pinhole leaks present, which were sealed using a clamp.

Area to be repaired with 3 pinhole leaks present

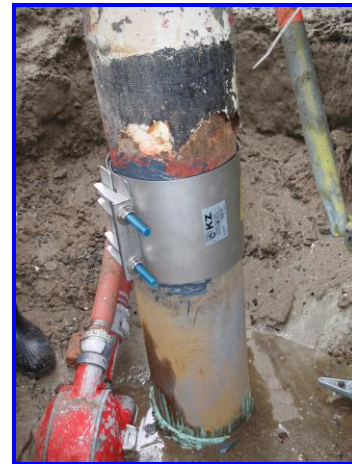
Clamp applied over the leaks and sealed with plastic steel

The leak was sealed using a clamp and plastic steel was placed around the edges of the clamp. The pipe was then cleaned using water and sand blasting.

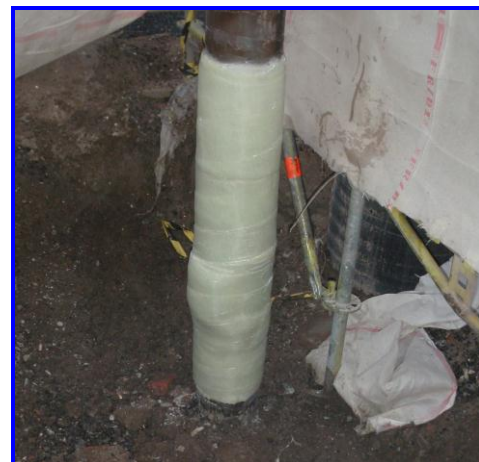
12 layers of Clock Spring Contour applied, the leak has been completely stopped

12 layers of Clock Spring Contour were applied over the pipe.

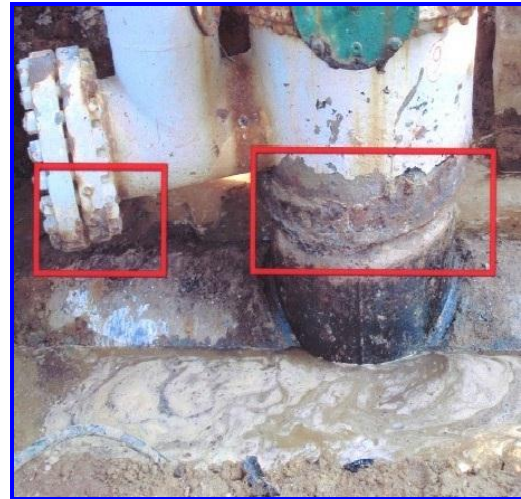
Wall thinning at the air to ground interface with some pinhole leaks. An encapsulation of the blind flange was also needed.

Area to be repaired

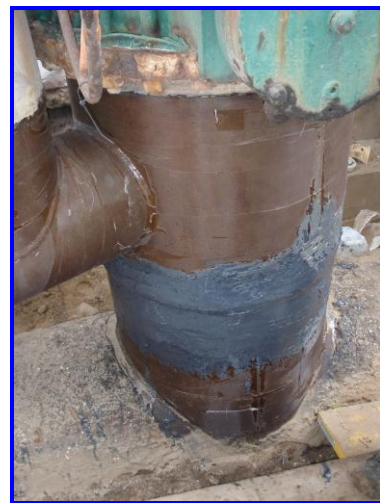
Plastic steel used to seal leaks and taper any sharp gradients

The pipe was cleaned using a slurry blast system. Pinhole leaks were then sealed with plastic steel and any sharp gradients were tapered out.

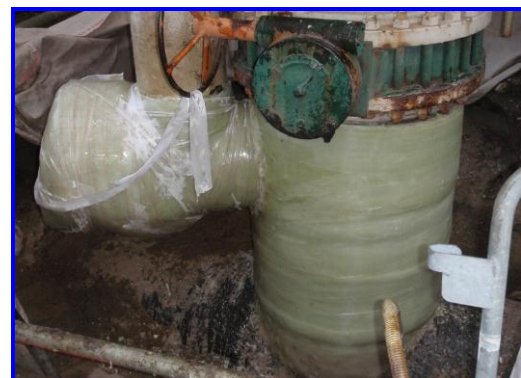
Repair nearing completion

19 layers of Clock Spring Contour were applied.

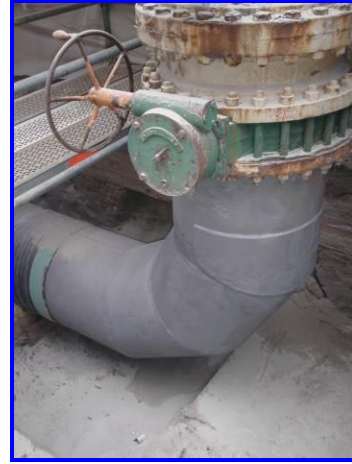
Area to be repaired after sand blasting

3.2 mm of wall thickness remaining.

The pipe was cleaned using water and sand blasting.

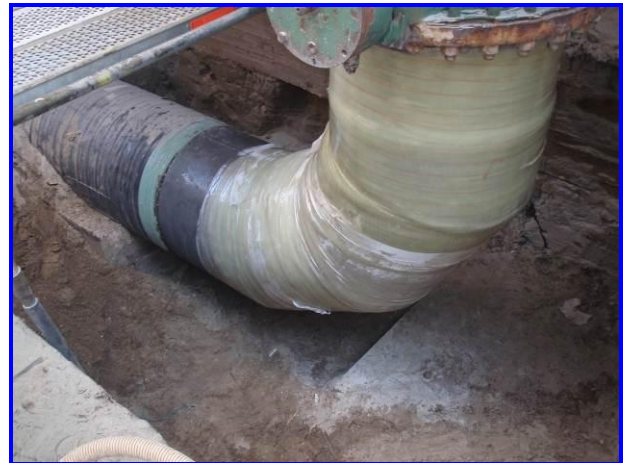
First 4 layers installed and left to cure

15 layers of Clock Spring Contour were applied over the pipe.

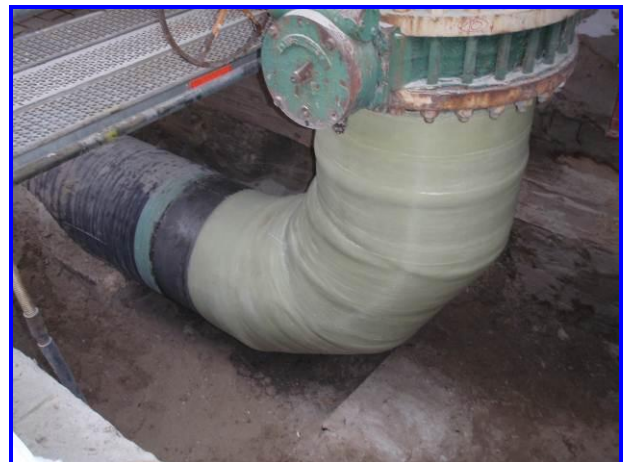
Completed repair

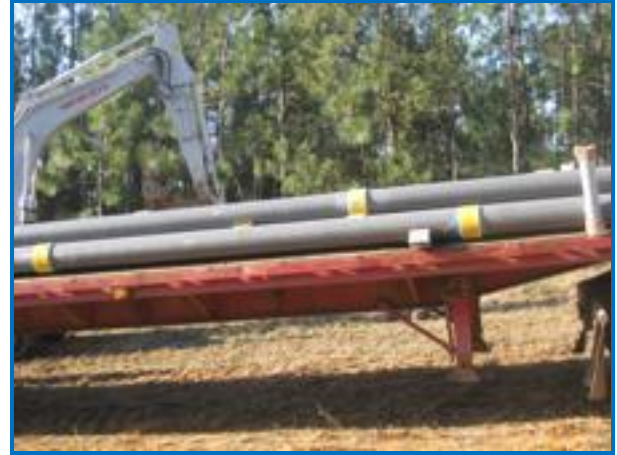
Clock Springs pre-installed on pipe sections

57 units, spaced 12' apart, were installed on new pipe sections in advance of installation. The crew of 10 installed all 57 units in 8 hours. Sections were then assembled on-site. Entire replacement of pipeline took approximately 4 days.

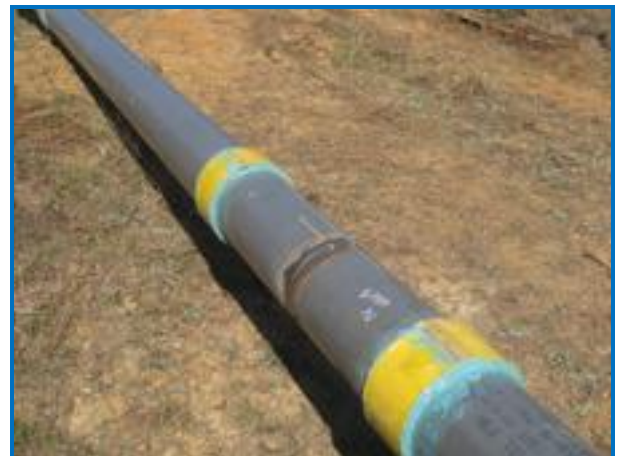
Casing spacers at girth weld joint

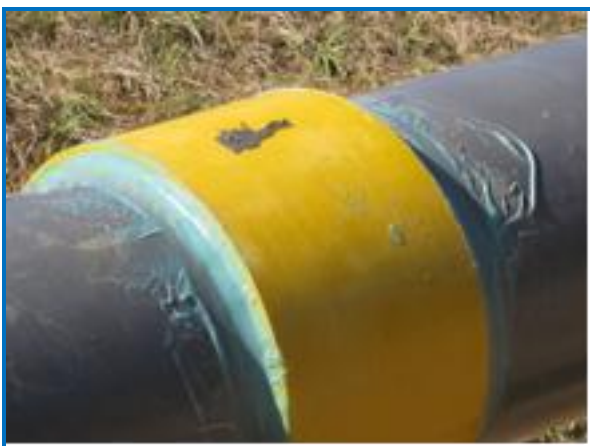
Clock Spring cut to 5 ½" width and installed as casing spacer

Existing pipeline was cut and pulled through casing for removal. Almost all of the existing casing spacers were broken, showed significant corrosion at bolts, and many failed to hold during pipe removal. Clock Springs were custom cut to 5 ½" widths and used as casing spacers to provide protection of girth welds and pipeline during installation.

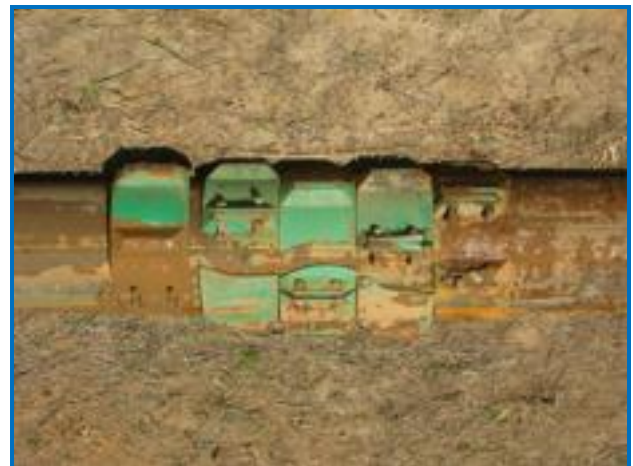
Pipe had defect from original pull where spacers failed to stay in place.

Spacers from old pipe, failed to stay in place when pipe removed – with corrosion

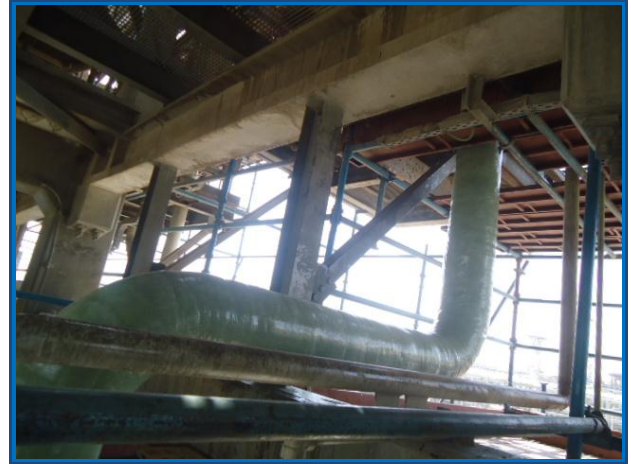
A vertical, horizontal and 2 bends repaired with Clock Spring Contour

The pipe was grit blast in a series of stages to Sa 2 ½ and then preserved using CS 600 epoxy resin and peel ply. 5 layers were then installed across the 30 m of pipe including bends and tees with full installation taking around 5 days.

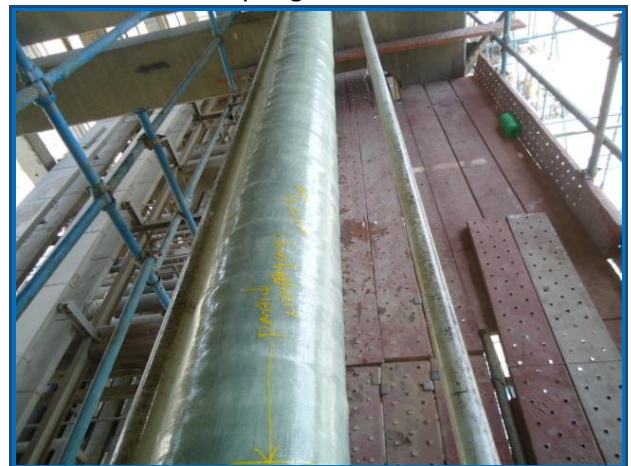
A straight section of pipe wrapped with Clock Spring Contour

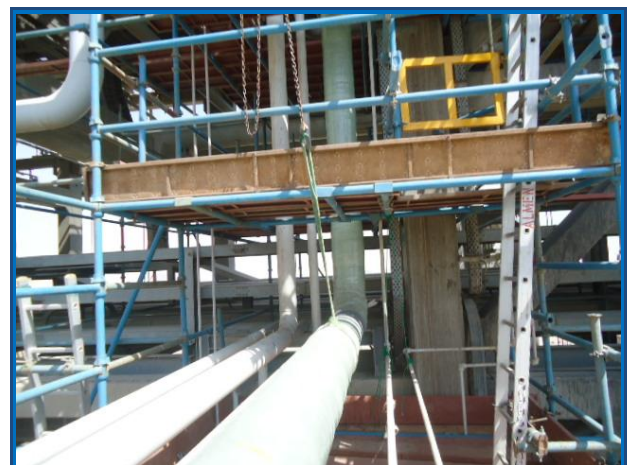
Vertical section of pipe, bend and horizontal section of pipe wrapped with Clock Spring Contour

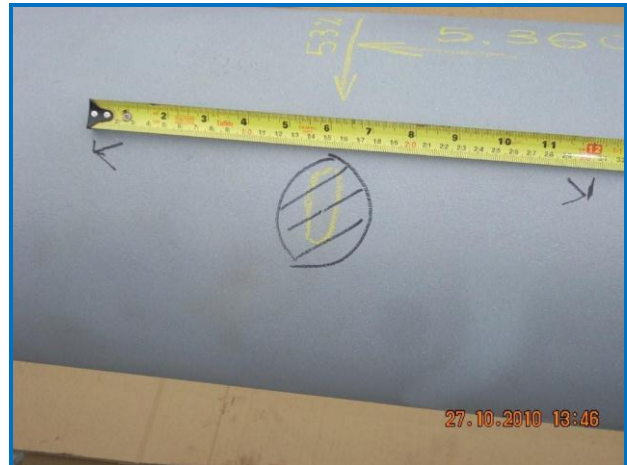
External corrosion due to a holiday in the corrosion coating which was spotted early due to regular pigging. A Clock Spring was applied to prevent further corrosion and reinforce the area of wall loss.

Pipe cleaned to Sa 2 ½ and defect area marked and measured.

Pipe was excavated and grit blast to Sa 2.5 prior to the application commencing. One 295 mm wide Clock Spring was placed over the defect with the installation taking 20 minutes. After 2 hours curing marker bands were installed, the repair was coated and the hole back filled.

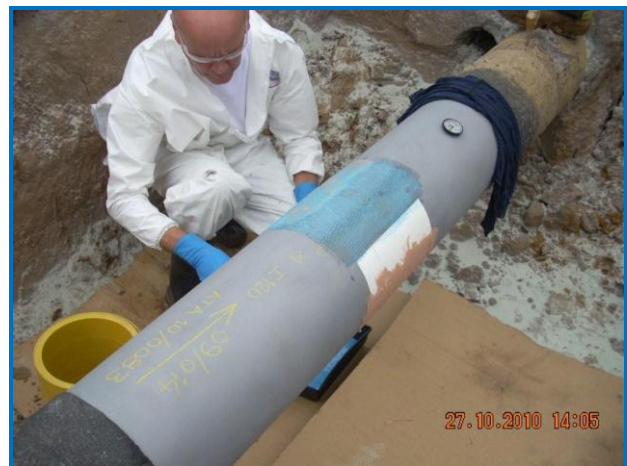
Installation of the Clock Spring Composite Sleeve using a trained technician.

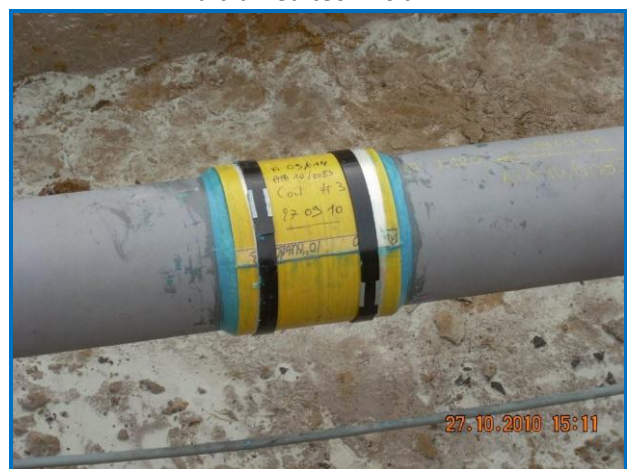
Repair completed and marker bands applied.

Clock Spring approved marker bands were applied to the edges of the repair, these highlight the repair area when future MFL pigging is used.
