CLOCK SPRING®

The Fast, Economical Solution for Low Pressure Pipeline Repair

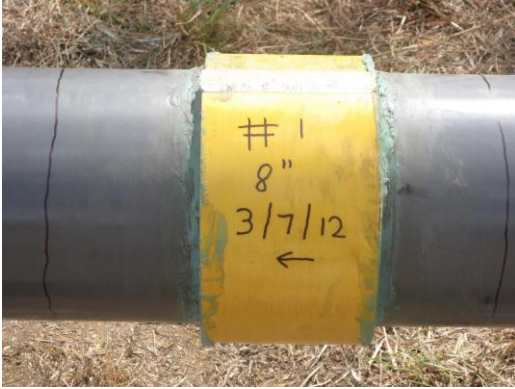
Before

Pipe had defect from original pull where spacers failed to stay in place.

Spacers from old pipe, failed to stay in place when pipe removed – with corrosion

Existing pipeline was cut and pulled through casing for removal. Almost all of the existing casing spacers were broken, showed significant corrosion at bolts, and many failed to hold during pipe removal. Clock Springs were custom cut to 5 ½" widths and used as casing spacers to provide protection of girth welds and pipeline during installation.
